Incline Fairview Phase III - Country Club Water Quality Improvement Project 2005-2006

Project Elements

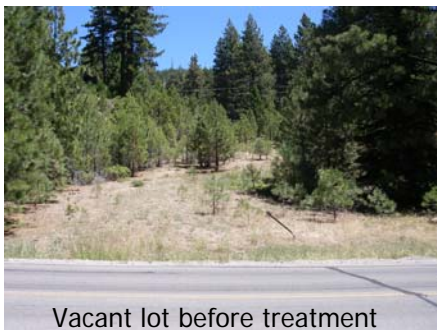
Vacant lot before treatment

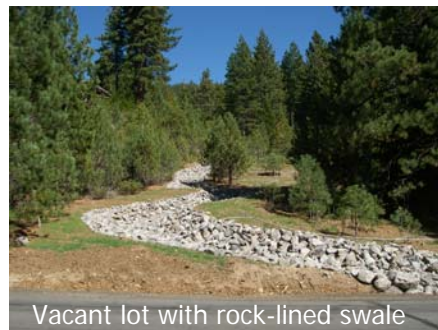
Vacant lot with rock-lined swale

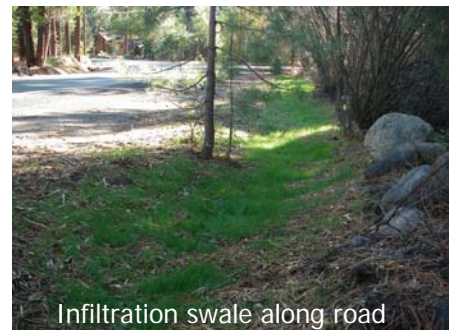
Infiltration swale along road
